**In the shadow of greatness:
An Investigation of the 1670 Church
at Historic Christ Church, Site 44LA55,
Lancaster County, Virginia**

April 2007

Submitted by:
DATA Investigations
1759 Tyndalls Point Lane
Gloucester Point VA 23062

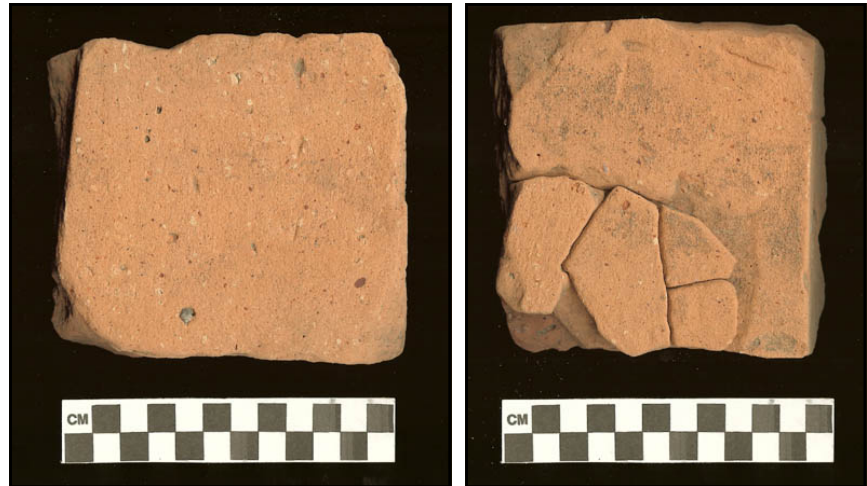
Figure 9. Top (left) and base of a ceramic floor tile (STP 124, N1125 E995).

Finally, a dark, round feature (Feature 7) was found intruding into Layer C and Feature 11 within Test Unit 38. Measuring 0.8 feet in diameter, the feature was initially interpreted as a posthole, possibly of a photographed late 19th-century fence that surrounded the Carter tombs. Upon further inspection, however, the round feature was determined to be one of John Metz's shovel tests (STP 124, N1125 E995). This shovel test yielded a nearly-intact course earthenware floor tile that was likely used as paving in the 1670 church (Figure 9) (Metz 1999).

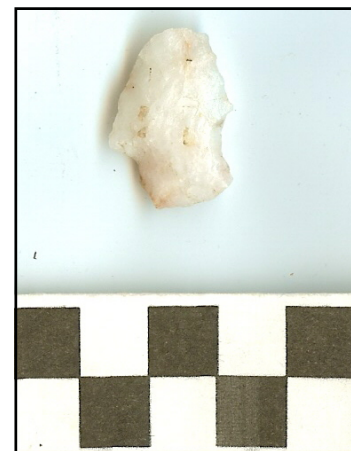
Figure 11. Possible Perkiomen type quartz projectile point (TU 26B).

Placed near the southeast corner of the churchyard, Test Unit 26 (N1032.5/E990) contained four separate strata (see Figure 2). Layer A was a 0.20-foot thick topsoil similar to that found across the project area. The soil was a dark brown (10YR5/3) sandy clay loam. The small quantity of artifacts from Layer A included cement, limestone gravestone fragments, bottle glass, a wrought nail, and handmade brick. Layer B consisted of a 0.5-foot thick stratum of brown (10YR4/3) sandy loam mottled with pale brown (10YR7/3) clay. Like the layer above, Layer B contained artifacts both modern and colonial, in addition to a small quantity of Native American pottery and lithics. The 19th- and 20th-century finds included fragments of asphalt and automobile windshield glass, a press-molded whiteware ceramic fragment, wire nails, slate roofing tiles, and fragments of sand-tempered mortar and machine made bricks. The colonial-era finds included case bottle glass, carved sandstone from a grave marker, and shell-tempered mortar and handmade bricks. Finally, the Native American material included two fragments of sand tempered coil-built pottery with fabric impressions, a single chert flake, and a biface knapped from white quartz (Figure 11). The biface is complete, except for its broken proximal tip. The biface's blade is asymmetrical and closely resembles a Perkiomen type characteristic of the Late Archaic (1700 to 900 BC) (Hranicky 1994:69).

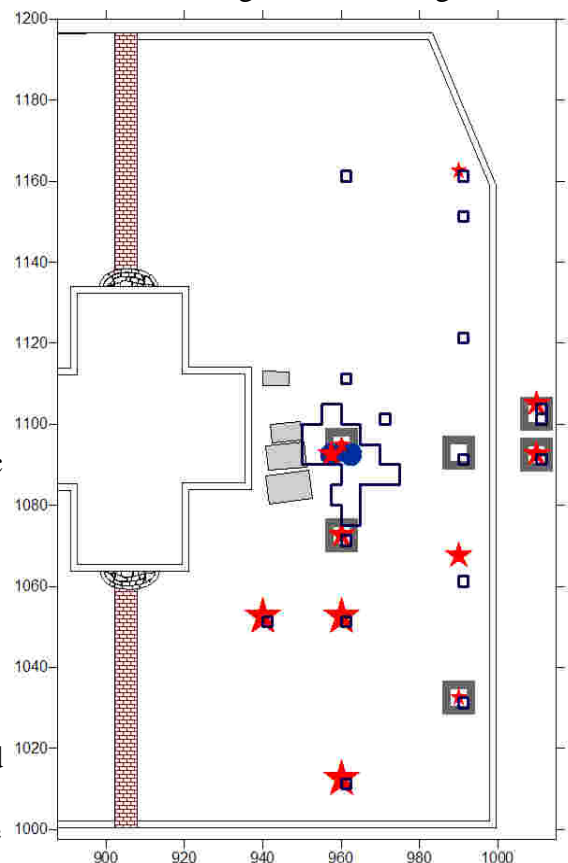
Figure 20. Indications of site integrity using the presence of prehistoric pottery in the topsoil [blue circle], restoration layers [square], and colonial layers [red stars].

Despite more than three centuries of historic use of the property, including construction and repair of two churches, construction, destruction and reconstruction of churchyard walls, numerous burials and general maintenance of the churchyard, the integrity of the archaeological deposits appears quite good. Examining the distribution of Native ceramics across the site, there is correspondence between the recovery of sherds from the topsoil and restoration layers with native ceramics found in the older layers dating to the colonial period and before (Figure 20). While the bulk of native artifacts were found south of the North 1100 line, with test units containing the most native ceramics below the North 1060 line, the overlap between the two indicates that the activities that deposited the

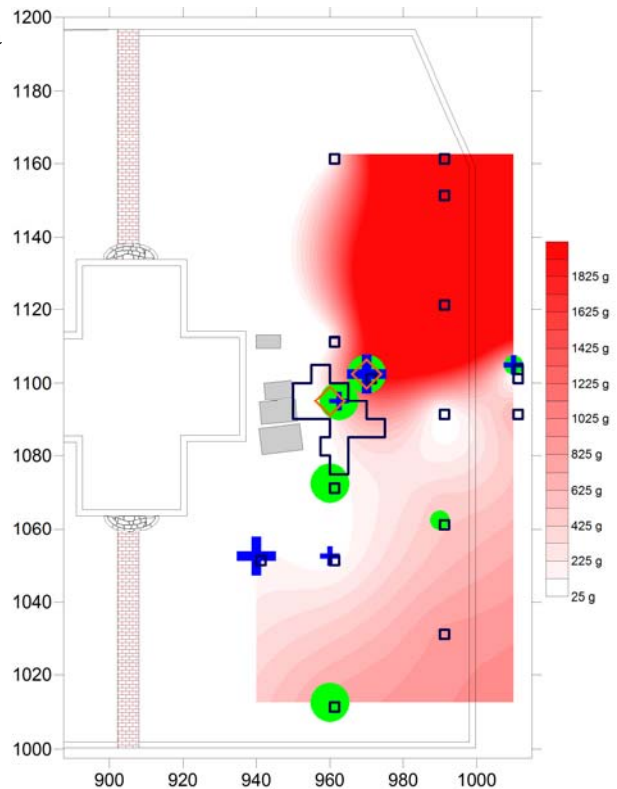
Figure 21. Concentration of colonial architectural artifacts (handmade brick [contour], wrought nails [cross], wrought/cut nails [circle], and window lead [diamond]).

Units 25, 29, 30, and 31 (see Figure 21). In contrast, similarly large amounts of brick from the restoration layers is clustered exclusively along the churchyard wall (Figure 25). These two concentrations indicate different events: filling a low area at the northern tip of the project area in the 18th century and the destruction and reconstruction of the churchyard wall in the 19th and mid-20th centuries. Shell mortar from the earliest layers was found exclusively along the northern and eastern edge of the proposed 17th-century church location, suggesting a possible correlation with the plastering of the 17th-century structure, or with the construction and landscaping activities of the 1730s. This contrasts sharply with mortar's exclusive concentration along the churchyard wall in all restoration deposits. Wire and cut nails, both used extensively in the 19th and 20th centuries, were recovered in the vicinity of the standing church and the tombs. These may relate to renovations and the presence of a fence surrounding the Carter tombs prior to restoration efforts. Wrought nails, common during the colonial period, were found dispersed across the site, but with a compelling concentration near the projected location of the 1670 church. In total, this evidence appears to indicate that the 17th-century church was a wood frame structure, incorporating leaded casement windows and plastered interiors. There was an explosion of activity during the 1720s and 30s as the brick kilns, new church, churchyard wall and landscaping efforts were undertaken, followed presumably by the removal of the 1670 church. The next significant period of activity begins with the replacement of the shingle roof with one of slate in 1897, followed by numerous 20th-century restoration efforts, and much of this is visible in the archaeological record as well.

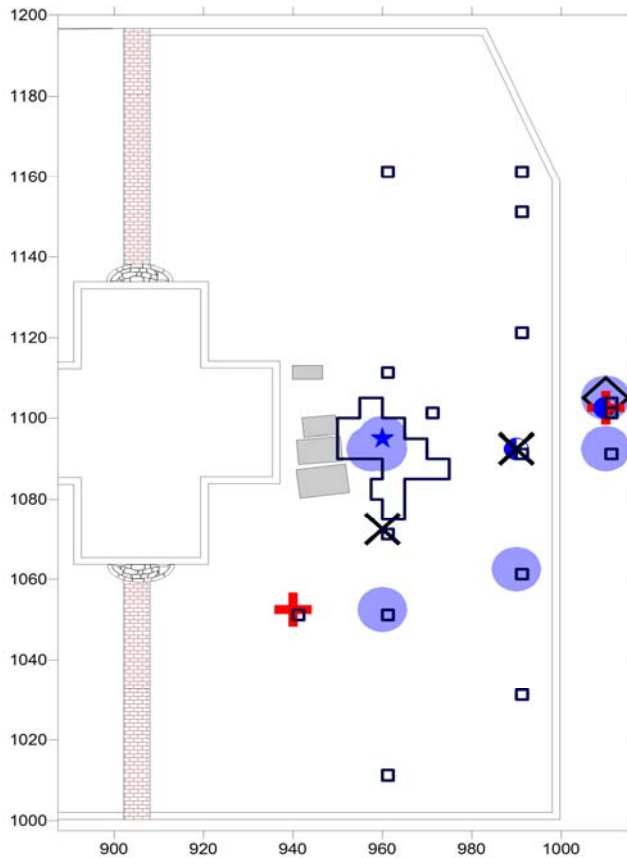
Figure 22. Colonial artifacts (flint [X], wine bottle glass [half-circle], upholstery tack [star], window lead [filled diamond], colonial pottery [cross], imported tobacco pipes [filled circle], and domestic tobacco pipes [open diamond]).

Seventeenth-century domestic trash, while sparse, further confirms a probable location for the 1670 church to the east of the Carter tombs (Figure 22). Imported tobacco pipes with large bore diameters and domestic tobacco pipes, the latter almost exclusively produced in the

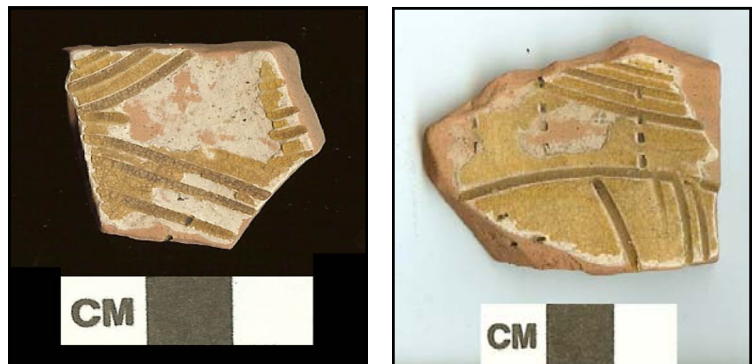
Figure 23. 17th-century North Devon sgraffito fragments (left: TU 50C; right: STP 118, N1065 E935).

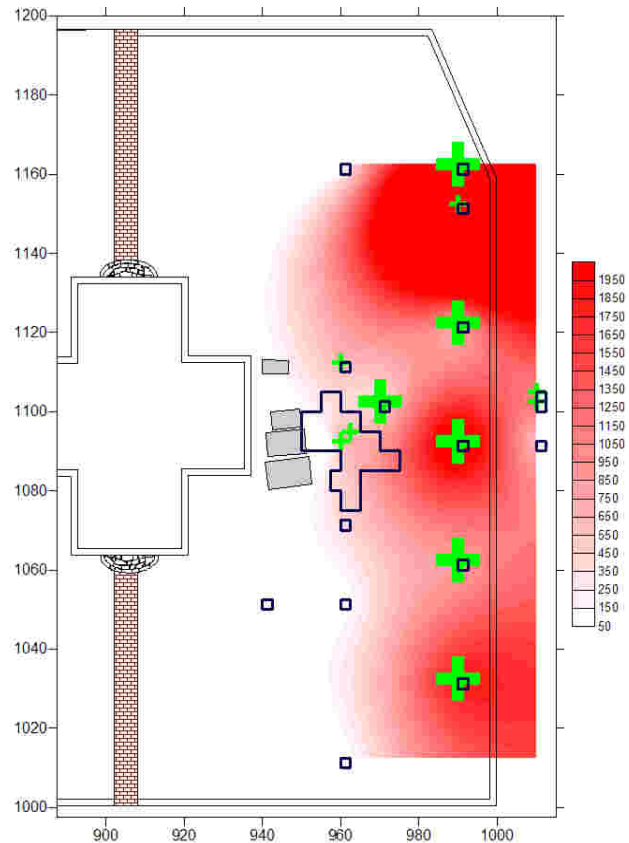
Figure 25. Distribution of brick and mortar in restoration layers (shell mortar fragments (cross) and handmade brick (contour)).

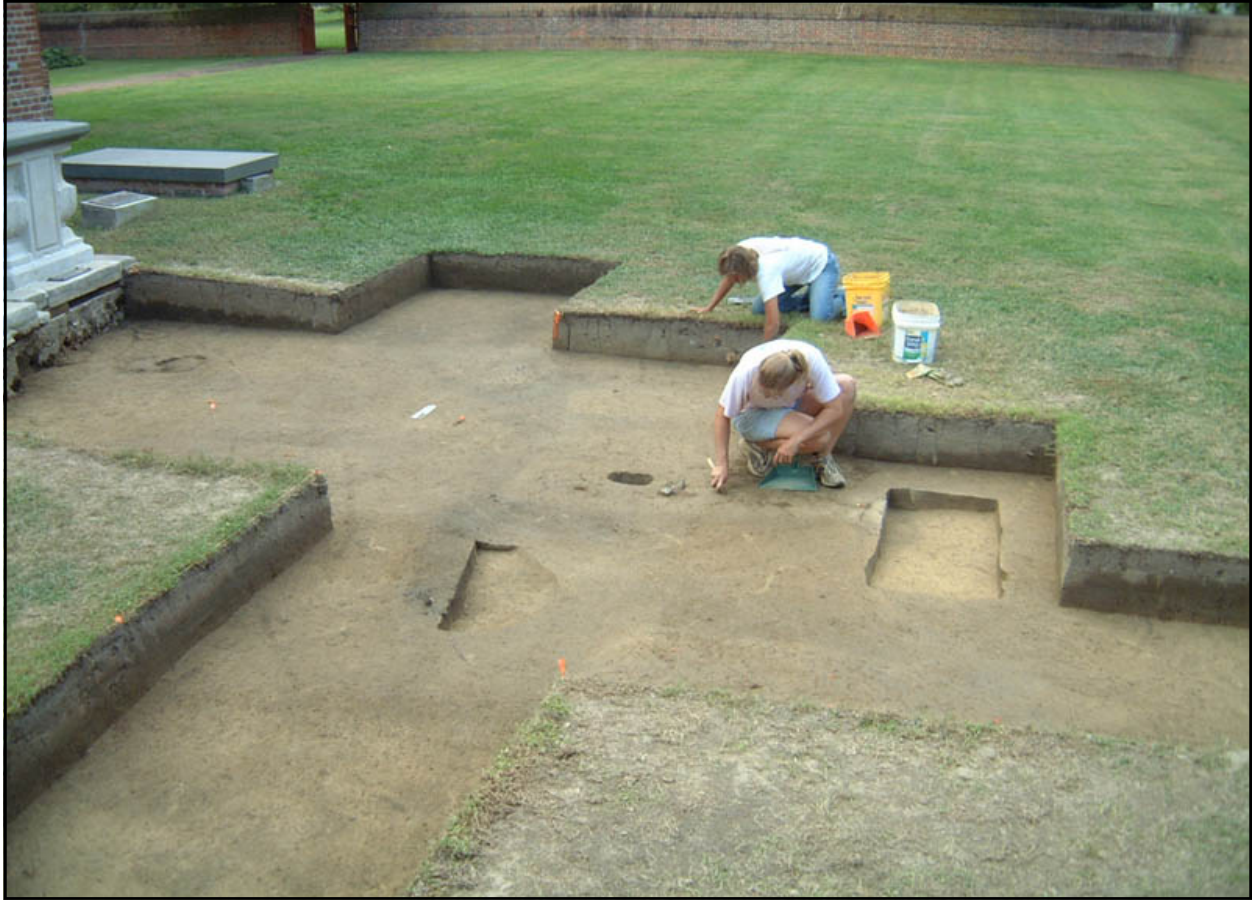
Figure 28. Sarah Heinsman (back) and Amber Rhodes cleaning the block excavation area.

Excavations followed the same methodology as employed during the Phase II. Groups of test units were excavated simultaneously whenever possible in order to more efficiently expose the block area (Figures 27 and 28). This also allowed for the complete exposure of larger features corresponding to the different periods of activity within the churchyard, such as the colonial topsoil layer and the restoration layer. As with the Phase II, artifacts collected in the field were organized by context and sent to the DATA Investigations LLC laboratory for processing and analysis where they were washed, identified, and inventoried (see Appendix A). Once again, slate, coal, asphalt, shell, concrete, brick and mortar weights were recorded prior to discarding these artifacts.

A test unit excavated by Carter Hudgins and students in 1986 was also identified and re-excavated (see Figures 28, 31, 32 and 35). Hudgins never completed a report locating or describing his excavations, but he recalled identifying a possible post hole at the base of one of his test units (Hudgins 2006). Excavations within Test Unit 45 located a test unit similar in shape and size to Hudgins' description, measuring approximately 2 by 4 feet and including modern string tied to large nails in three of the corners. In addition, a feature (Feature 11) was found in the west wall that extended partially across Hudgins' unit. This feature does resemble a posthole within the limits of the 1986 unit, matching with Hudgins' recollection, however, the Phase III block excavations encircled this earlier unit, exposing the entire breadth of Feature 11, an 18th-century adult grave shaft. It is interesting to note that both episodes of the limited earlier archaeology revealed portions of the same grave shaft, but neither was able to properly identify it. Despite the larger size of the current excavations, this limitation remains a problem.

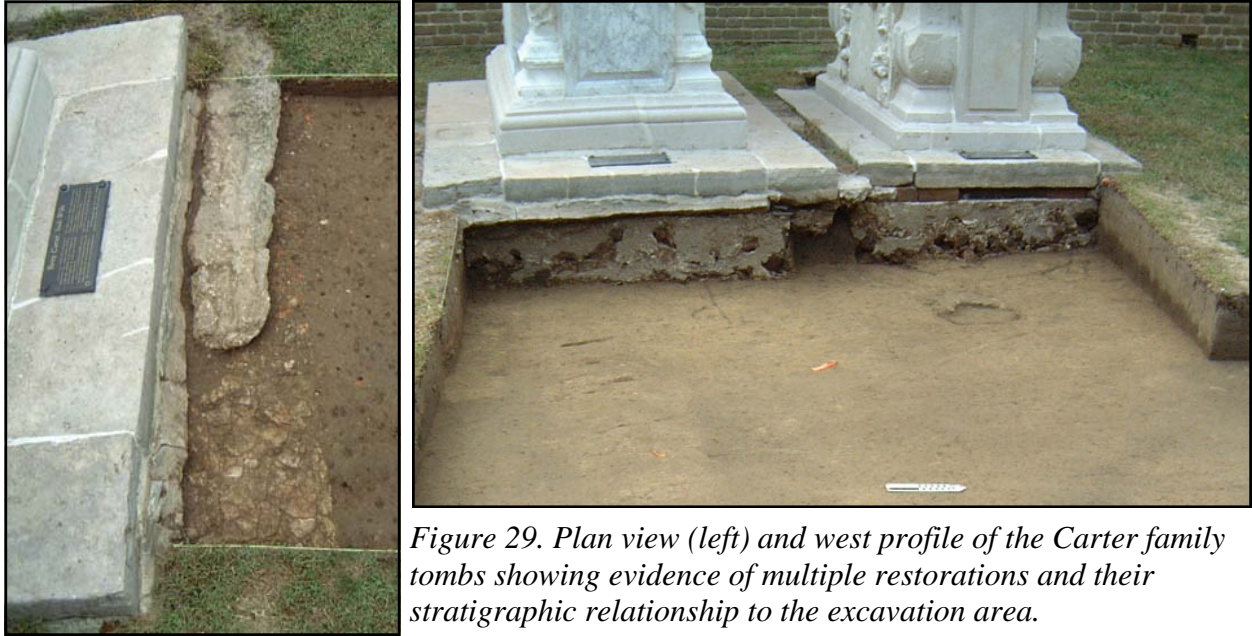
Figure 29. Plan view (left) and west profile of the Carter family tombs showing evidence of multiple restorations and their stratigraphic relationship to the excavation area.

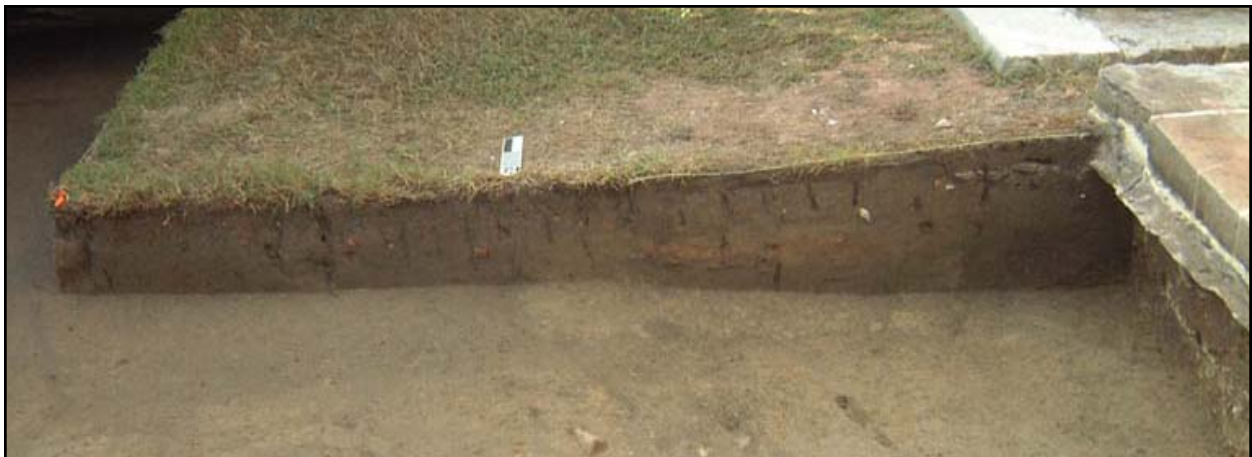
Figure 30. South profile of Test Units 42 and 43 showing depression above Feature 16..

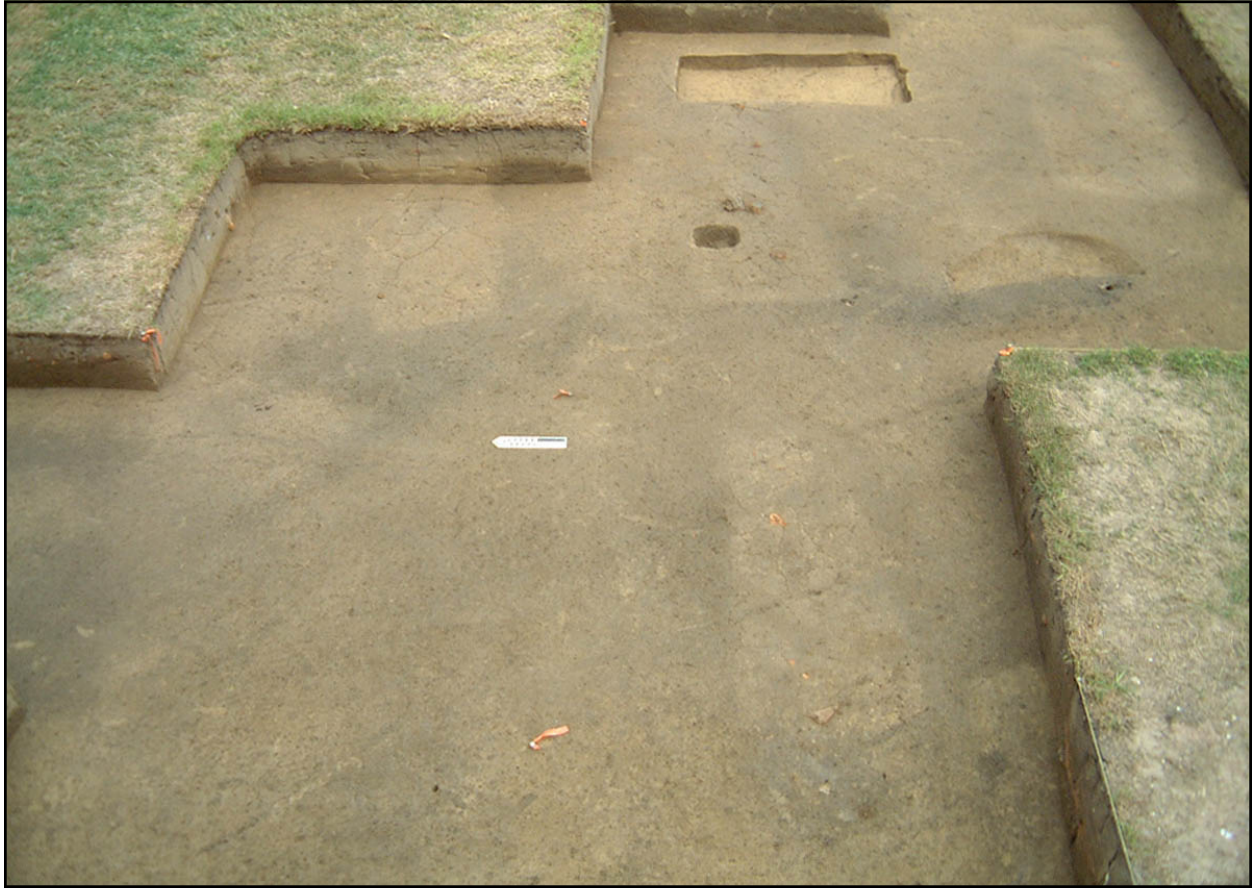
Figure 34. Excavation block looking east, showing Hudgins' test unit and various features.

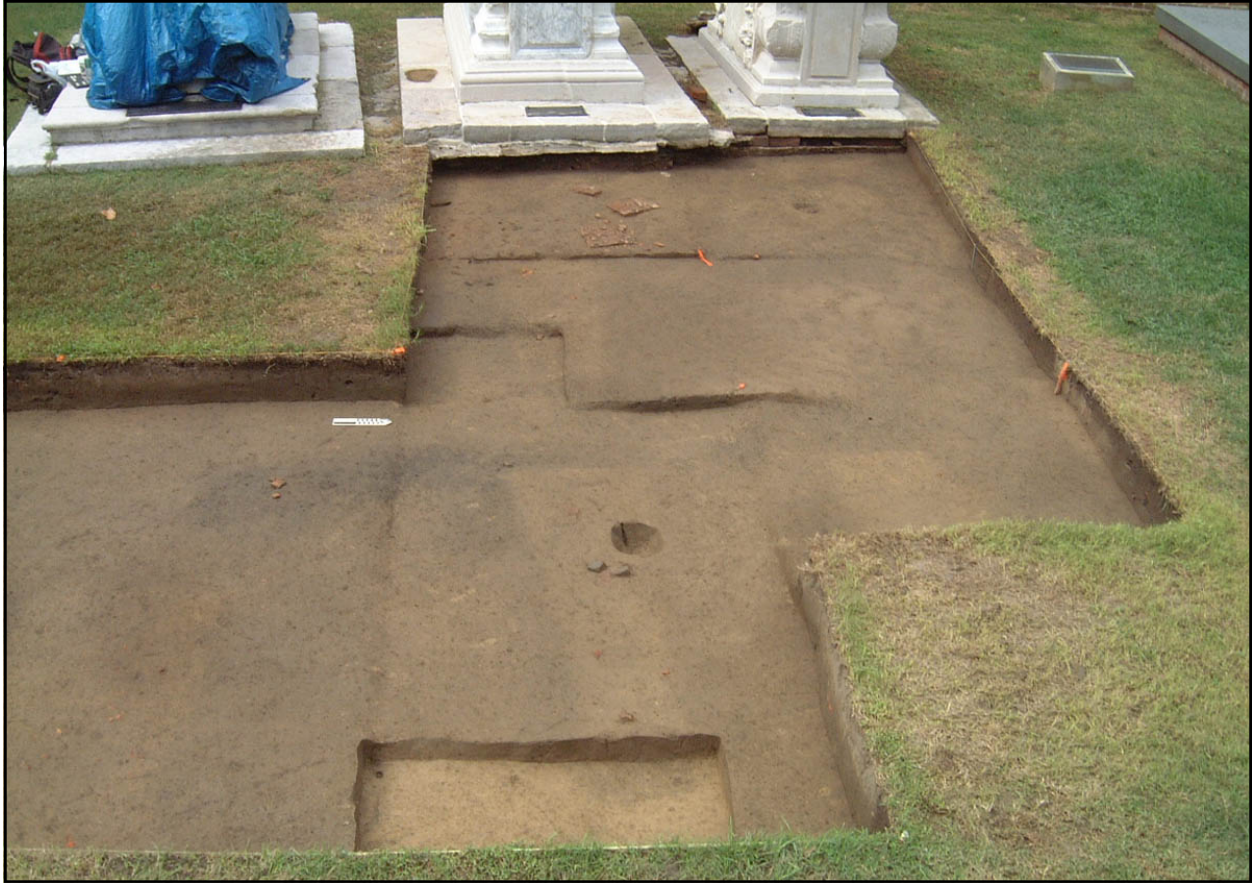
Figure 35. Excavation block looking west, showing Hudgins' test unit and various features.

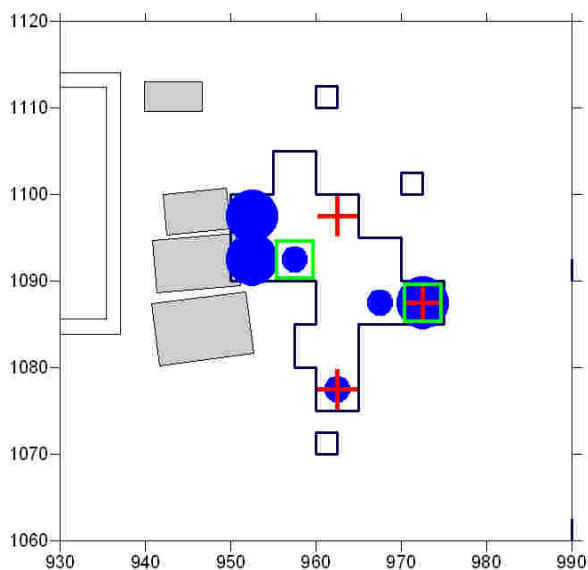
Figure 38. Prehistoric ceramics (Fabric-impressed (circle); net-impressed (cross); cord-marked (square)).

Native American ceramics, lithic debitage, and projectile points were found in similar amounts to those identified in the Phase II (Figure 37). While a spatial analysis of these materials over such a small area may prove less dynamic than that of the larger churchyard, the artifacts recovered support the initial conclusion that the ceramics, particularly those related to the Accokeek and Pope’s Creek traditions, were found in similar percentages to those seen in earlier phases of work at the site (Figure 38).

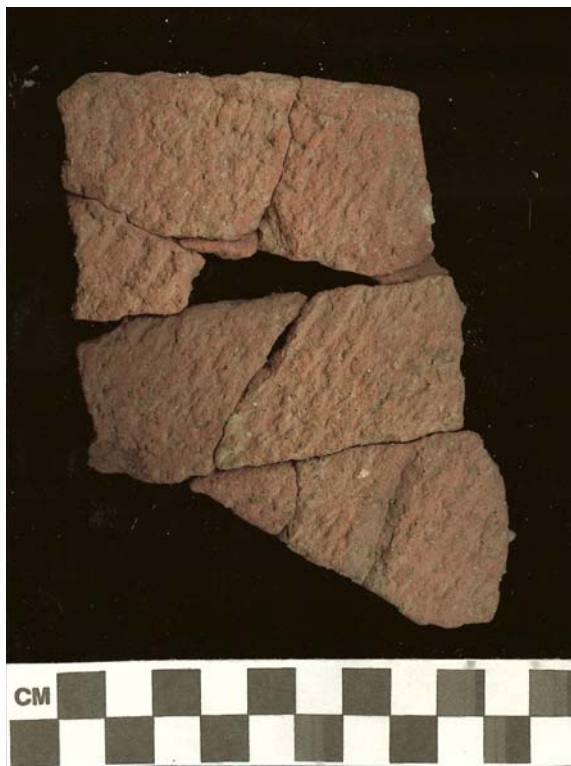
Figure 41. Crossmended sherds of a Pope's Creek pot, displaying net-impressed surface treatment (TU50C).

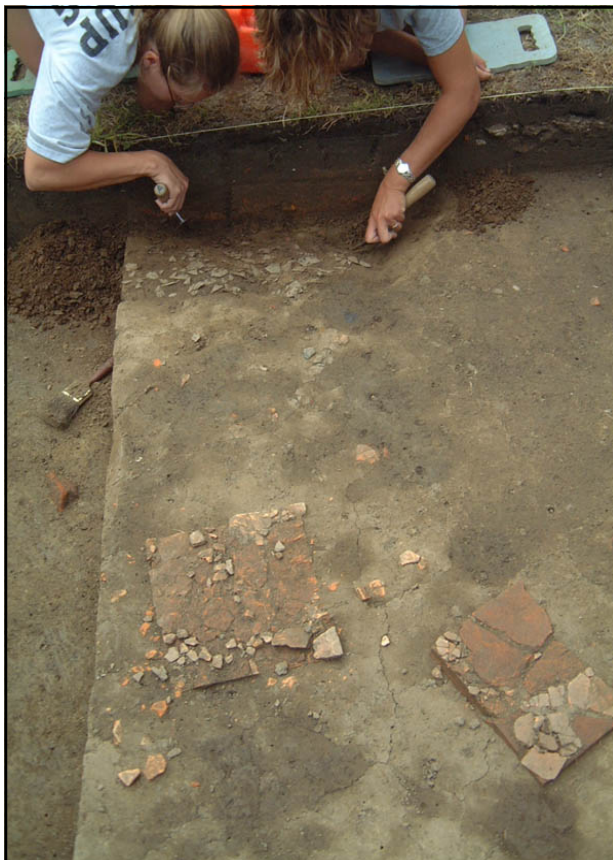
Figure 44. Amber Rhodes (left) and Sarah Heinsman excavate a concentration of window glass above Feature 16 (Layer D1). A complete (left) and partial 1670 church floor tile are in the foreground.

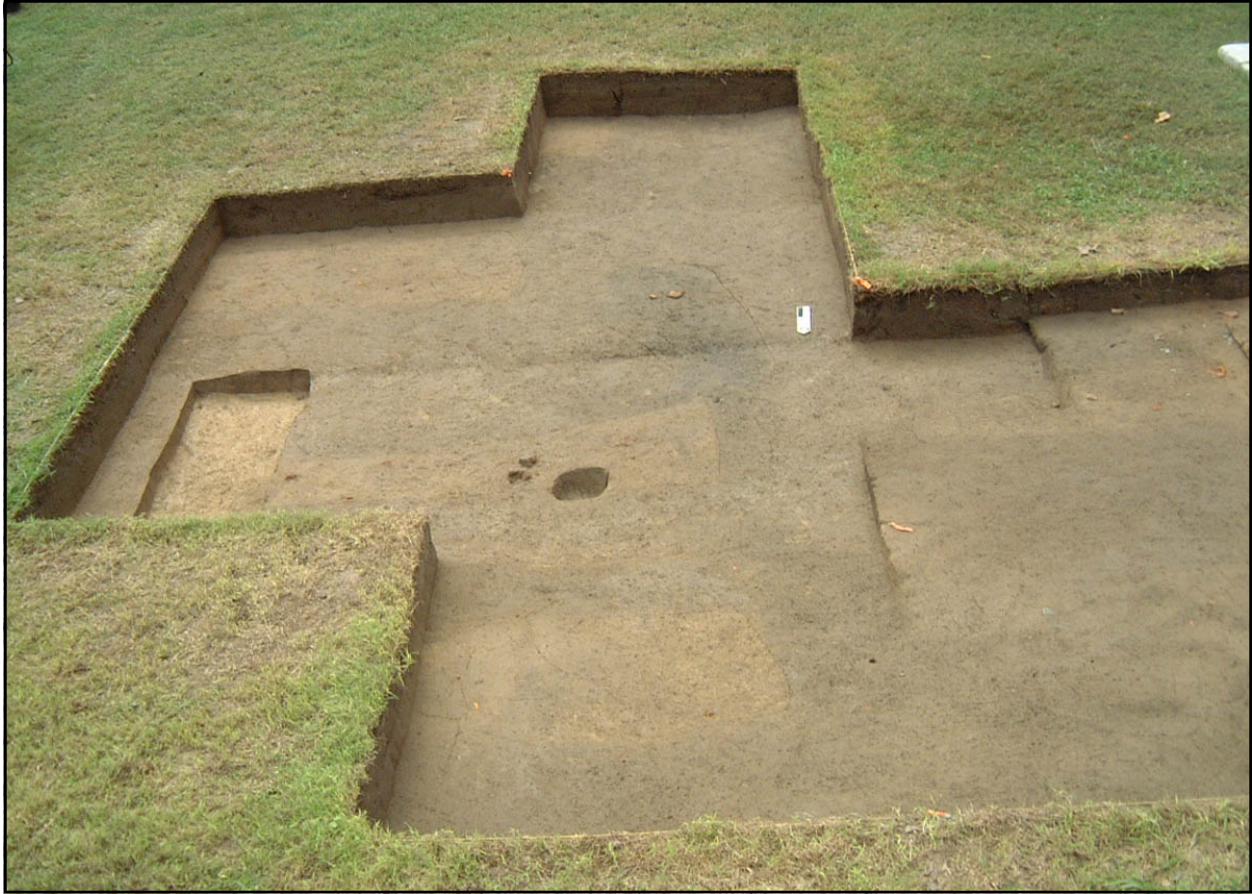
Figure 45. Block excavation area looking south.
