Christ Church Drainage Project – Update on Excavations December 8, 2021

Southwest Churchyard Low Point Trench

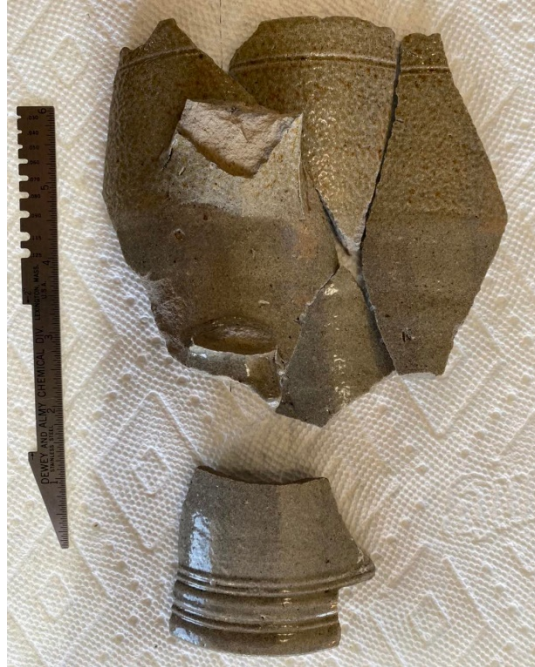
18th-century stoneware mug found in the southwestern churchyard trench.

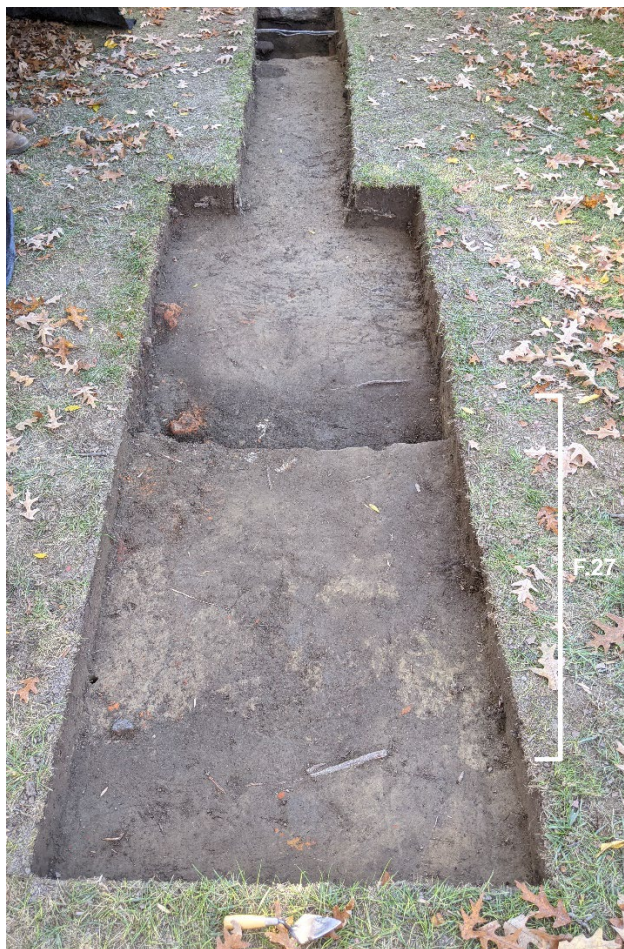
Southwestern churchyard trench showing possible burial feature.

The 20' trench in the southwest churchyard is located between 30' and 32' south of the western sidewalk leading from the lowest point in the churchyard to the wall. This trench was generally excavated in two layers: a dark, loamy topsoil with an older layer underneath. Subsoil was reached in this area at approximately 0.8' below ground surface. Very few artifacts were uncovered in these excavations, with a notable exception of multiple sherds of an English stoneware drinking vessel that mend together. This mug or tankard dates to the 18th century, and its presence in the churchyard raises some interesting questions about what activities took place in religious spaces. Additionally, a large feature was identified at the base of the older topsoil layer, which consisted of a light-colored clay cap on top of a dark loamy soil. This feature is possibly a burial, with the darker soil representing the original grave fill and the clay cap representing leveling efforts (grave shafts often leave a low spot on the surface, either from natural settling of soils or the eventual collapse of the coffin). However, the shape is somewhat odd for a burial, given that it is only 5' long (east-west) while also being over 4' wide (north-south), so this could also be some other kind of feature such as early landscaping efforts.

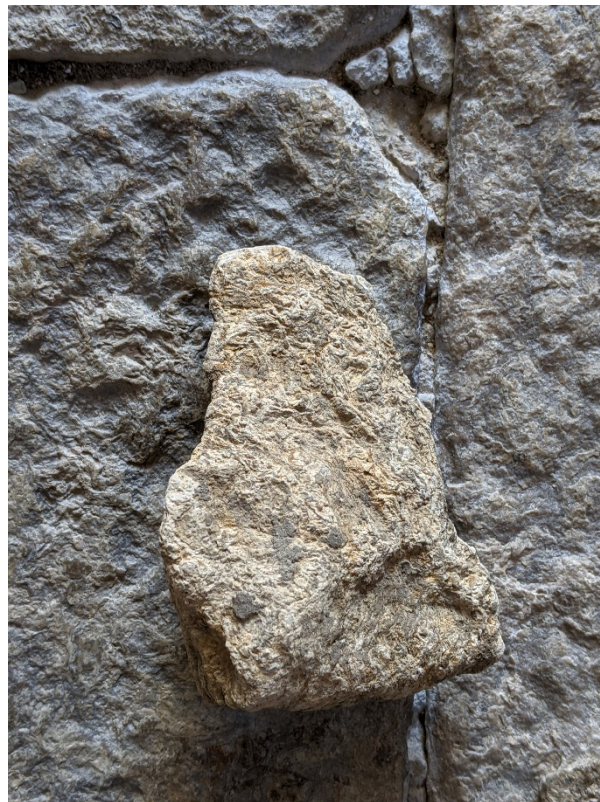
Comparison of an excavated stone fragment to the stone present in the floor of the church – note the same fossiliferous inclusions in both stones.

Beneath this was a layer of rubble with handmade brick, mortar, and stone (III). The stone found in this layer appears to be an exact match to the imported English stone present in the floor of the church. This, combined with the lack of later artifacts such as slate, means this layer is likely related to the construction of the extant 1735 church. In the northern portion of the unit, closest to the church, there was a lighter-colored clay lens (IV) directly beneath this rubble. This is likely a lens of deeper clay subsoils which were redeposited when the builder's trench for the church was dug. Together, these two layers tell the story of the church's construction: first the excavation of a deep trench into which the church's foundation was built, followed by the construction of the brick, mortar, and stone elements of the church.

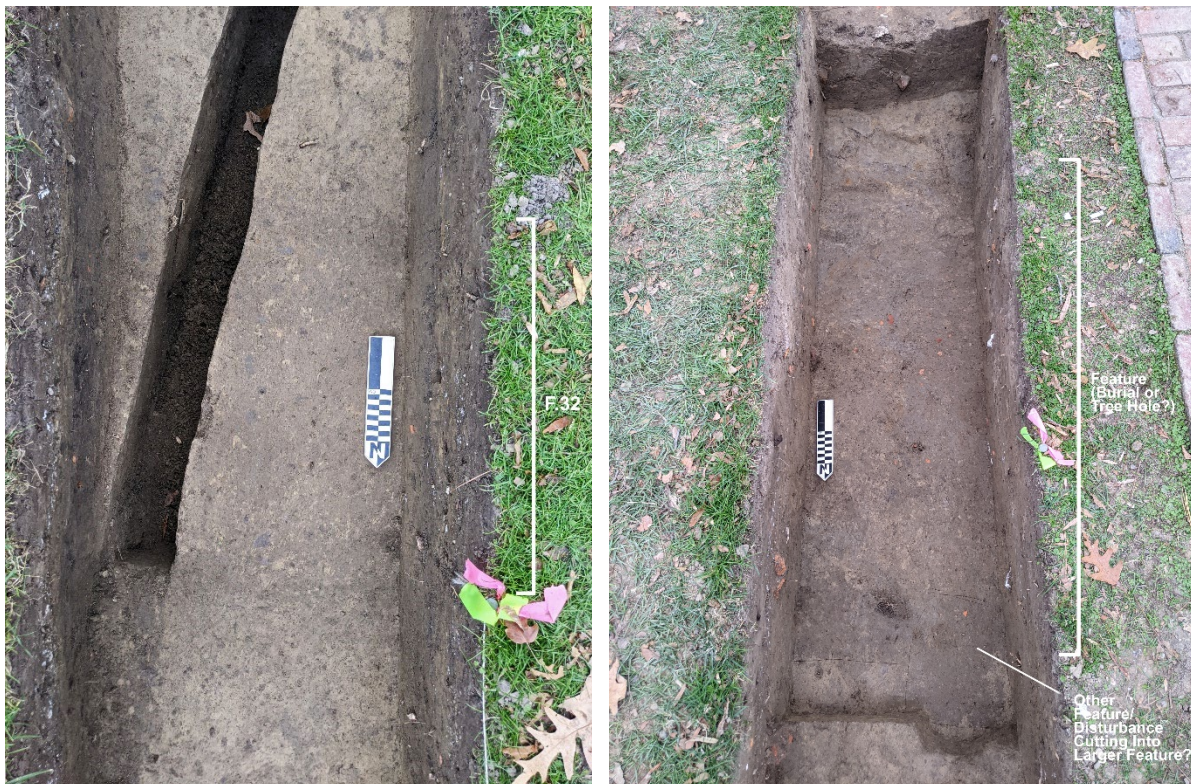
LEFT: Likely burial feature in the south trench, defined by grayish soil in center with a darker “halo” either side.

RIGHT: Another large feature in the same trench, either a double (or more) burial with another small feature cutting into the SE corner, or a large tree hole.

Two other possible features have been identified in this southern portion of the trench. One is a dark brown feature which has been cut by the utility trench (left photo below). This feature is most likely a burial, given its depth, shape, and characteristic “halo” of darker soil as noted in other burials in the churchyard. The feature is at least 1.4’ deep from original ground surface, based on its profile in the excavated utility trench, and at least 2.7’ below ground surface as it exists today. A second possible feature was identified recently, but further investigation is needed to determine if this is a burial, tree hole, or other kind of feature (right photo below). Some interesting artifacts to come out of this area are a plated copper-alloy ring fragment, possibly in the shape of a crown, and a fragment of ceramic tile associated with the earlier 1670s church.

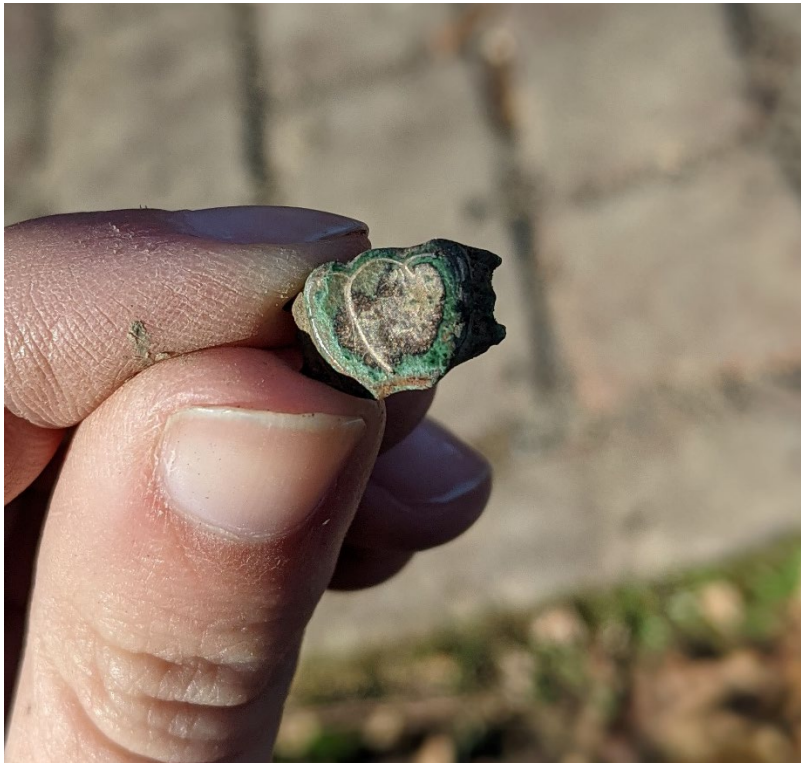
Possible ring fragment made of a copper alloy (note the green patina) and plated with another material to appear gold.
